Subject: **April 2012 Compliance Evaluation Inspection**

**CWA COMPLIANCE EVALUATION INSPECTION REPORT  
U.S. ENVIRONMENTAL PROTECTION AGENCY, REGION 5**

L'Anse Warden Electric Company  
John H. Warden Station  
157 South Main Street  
L'Anse, Michigan 49946  
46.755555, -88.455555

MI0006092

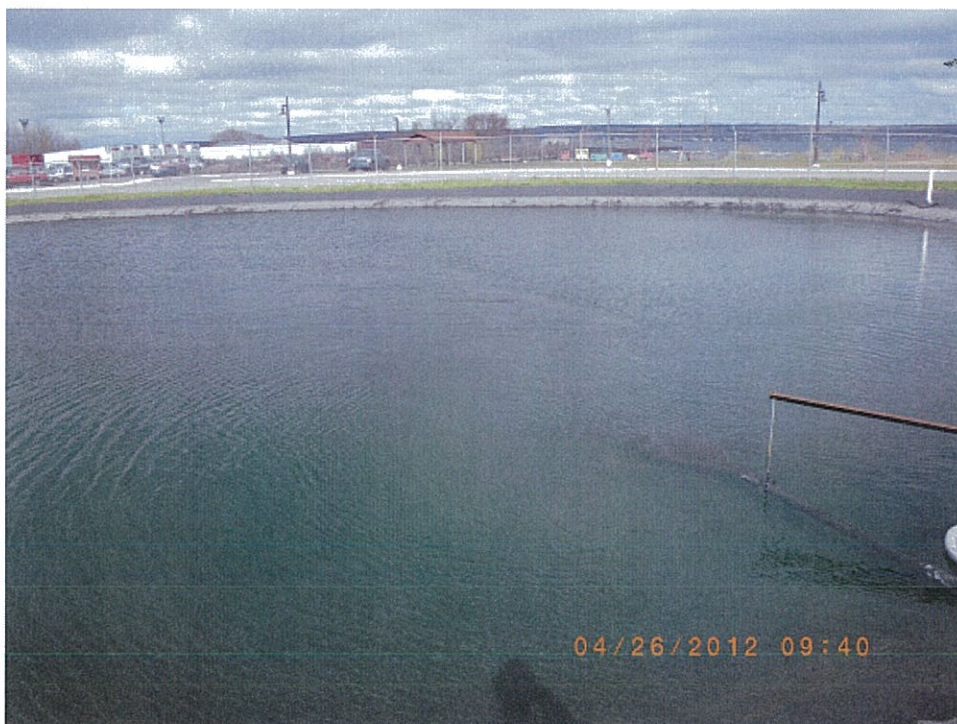
I observed effluent pond 3, adjacent to the facility entrance and on the northwest side of the generating station (Photo IMGP0924). Storm water and process water is pumped from a sump inside the generating station into effluent pond 3 (Photo IMGP0921 and IMGP0923). I observed that at the time of the inspection a submerged pipe was discharging dark grey, ash colored, water into effluent pond 3 (Photo IMGP0924). 33,000 gallons per day (GPD) of wastewater is discharged from effluent pond 3, which has an approximate capacity of 360,000 gallons (Photo IMGP0925), into Keweenaw Bay, Lake Superior (Photo IMGP0971 and IMGP0972). Darryl Koski stated that discharges are performed manually.

Photo IMGP0924: Effluent pond 3, note the ash colored discharge from the submerged pipe.  
Direction: Facing northwest.

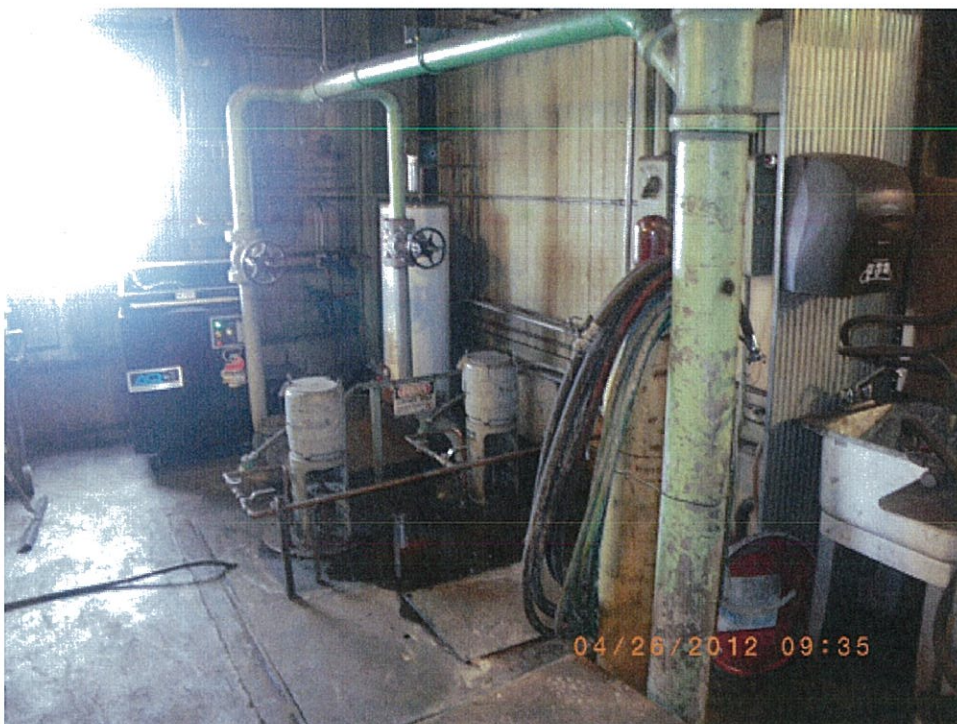
Photo IMGP0921: Sump inside of the generating station that discharges to effluent pond 3.  
Direction: Facing north.

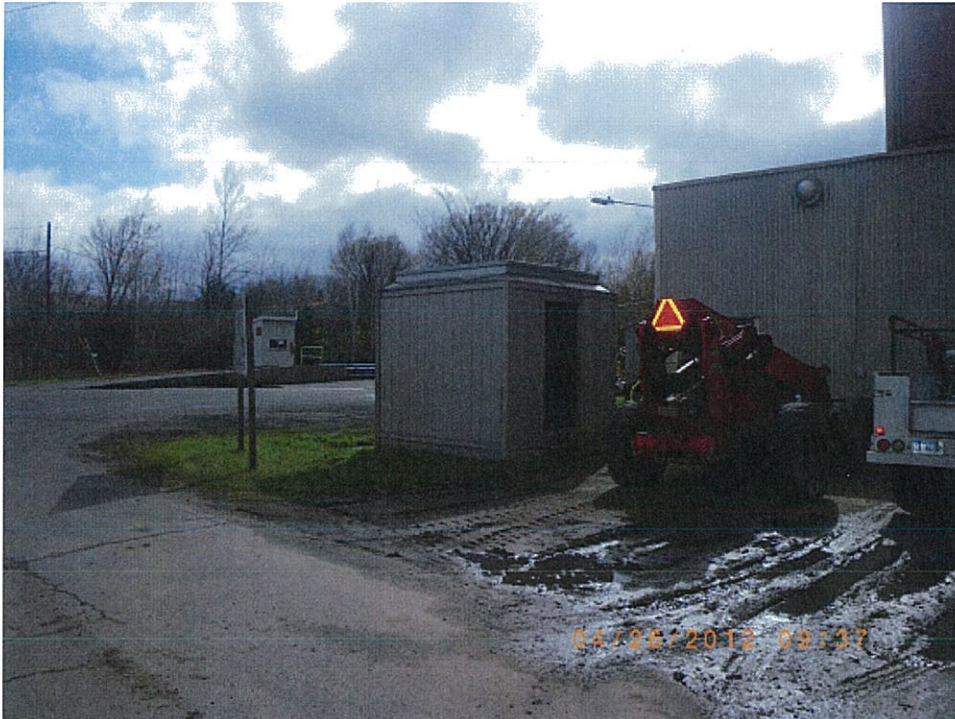
Photo IMGP0923: Effluent pump house on the north side of the generating station.  
Direction: Facing east.

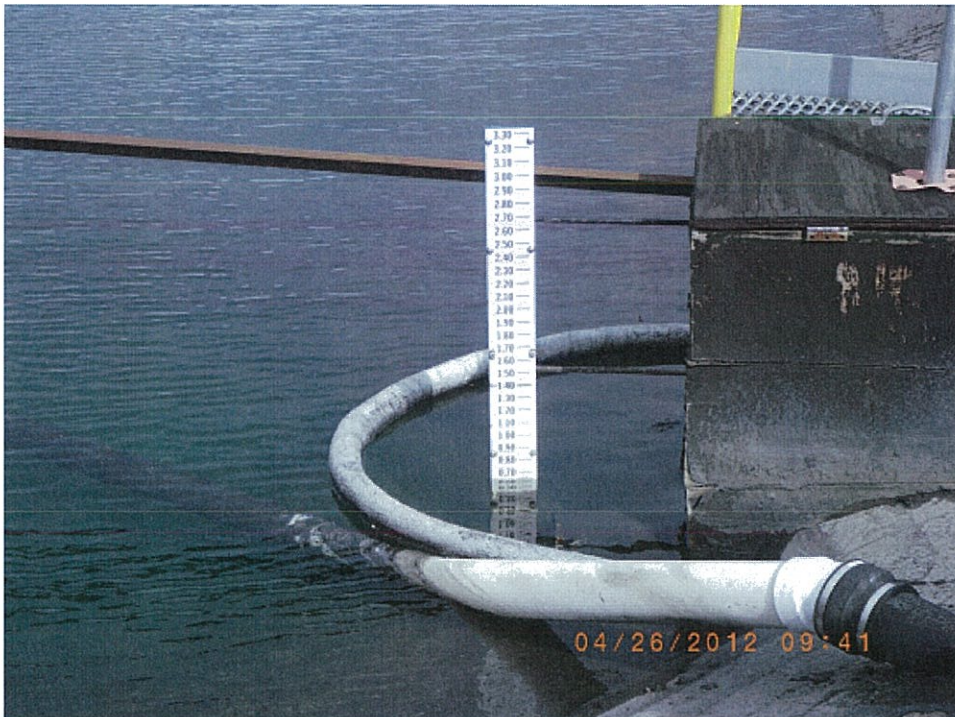
Photo IMGP0925: Effluent pond 3 discharge point and staff gauge used to determine discharge volume.  
This is also the sampling point for outfall 002.  
Direction: Facing north.

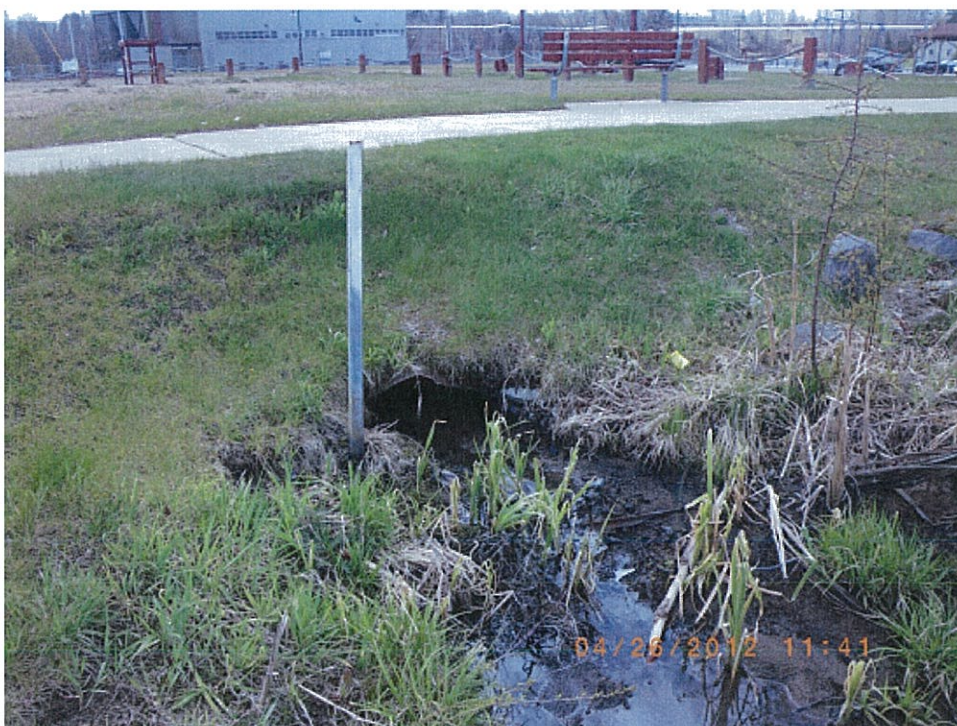
Photo IMGP0971: Discharge culvert from outfall 002 into Keweenaw Bay, Lake Superior. Note the generating station, the grey building, in the background.  
Direction: Facing southeast.

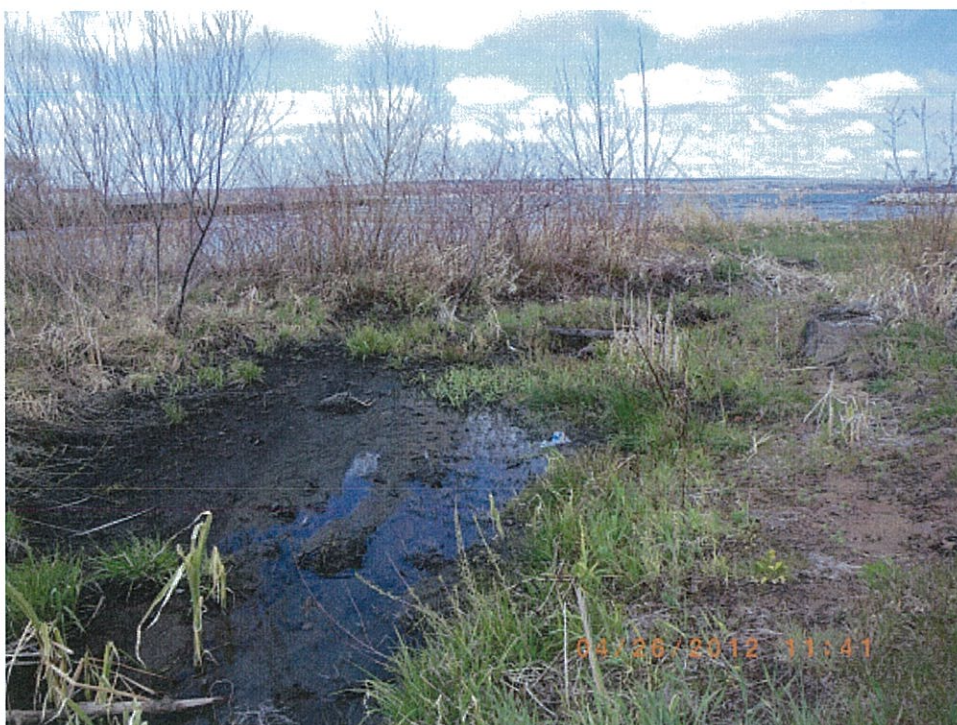
Photo IMGP0972: Discharge pathway from outfall 002 into Keweenaw Bay, Lake Superior.  
Direction: Facing northwest.

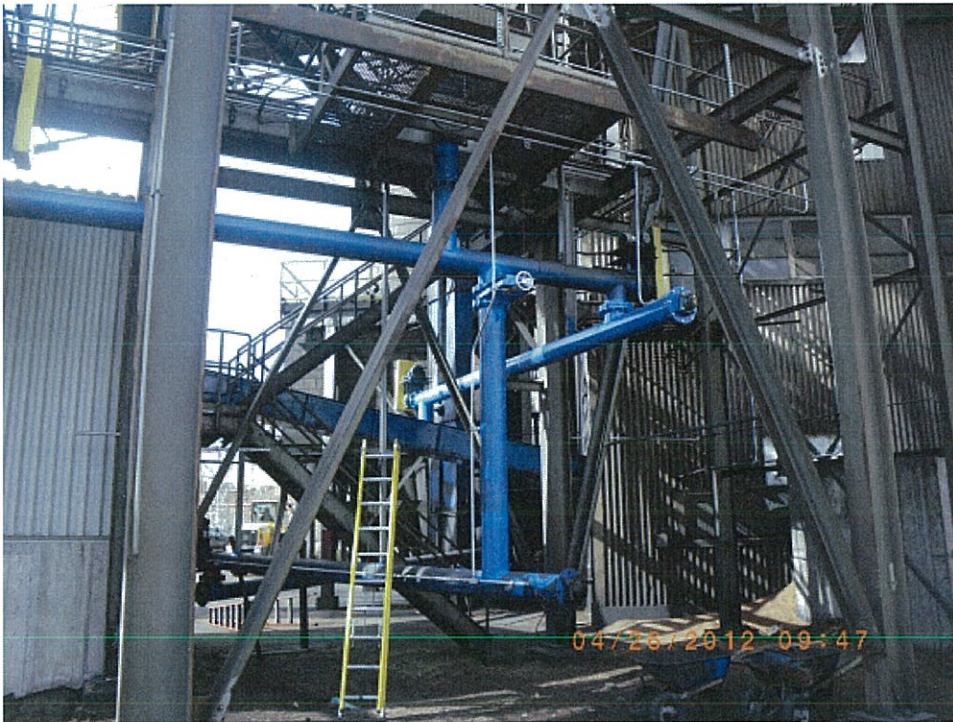
Photo IMGP0926: Ash handling system that used a screw auger piping system to move wetted bottom and fly ash from to the ash storage building.  
Direction: Facing west.

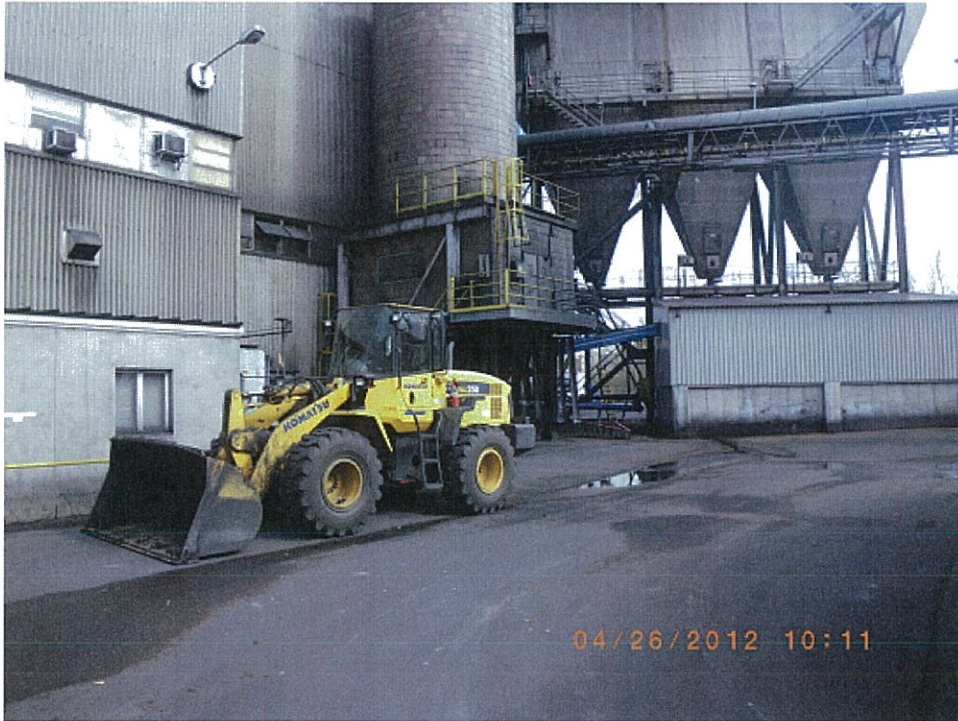
Photo IMGP0942: Front end loader used to transfer ash with the ash storage building in the background.  
Direction: Facing northeast.

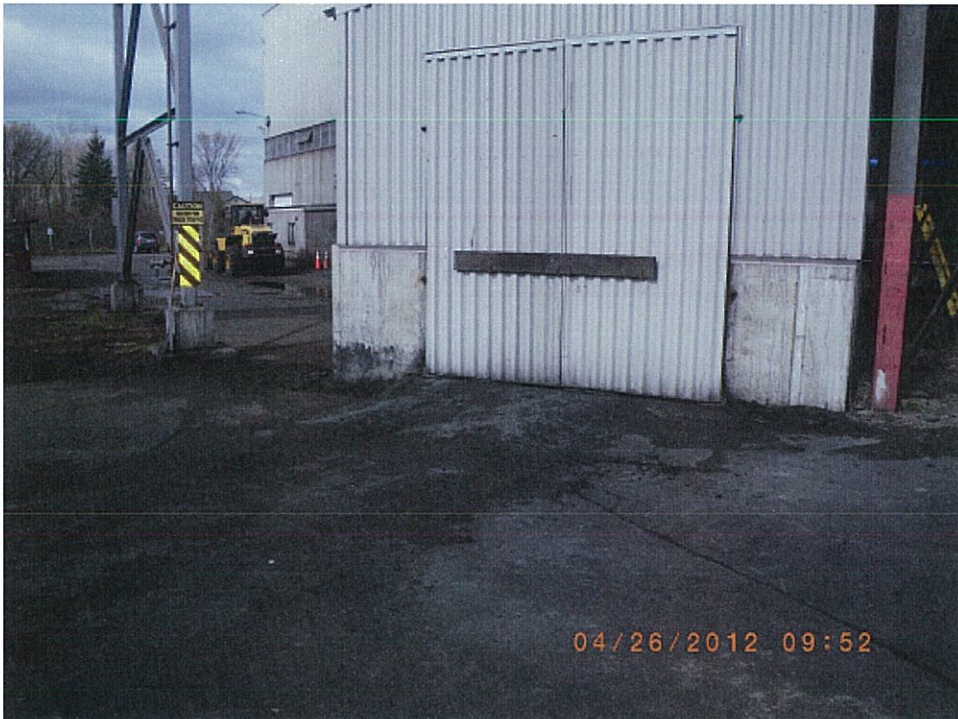
I observed the ash collection and handling system that combined and transported both bottom ash and fly ash to the ash storage building (Photo IMGP0926). Ash handling and transport is in a closed system until it is transferred using a front end loader (Photo IMGP0942), from the ash storage building into trucks for removal. On the day of the inspection, I observed ash that had been tracked and spilled outside of the ash storage building (Photo IMGP0929).

Photo IMGP0929: Ash that had been tracked and spilled on the asphalt outside of the ash storage building.  
Direction: Facing west.

3. Section 4.0(G), and 7.0(E)(1) of the SWPPP state that ash and solid biomass spills identified would be cleaned up swiftly. This is not consistent with the ash (Photo IMGP0929) and wood fines (Photo IMGP 0935) that I observed on the day of the inspection.

Continued implementation of the current SWPPP will help to mitigate storm water contamination and runoff from JHWS. Good housekeeping practices including sweeping should be done as needed, which may be multiple times daily around areas such as the

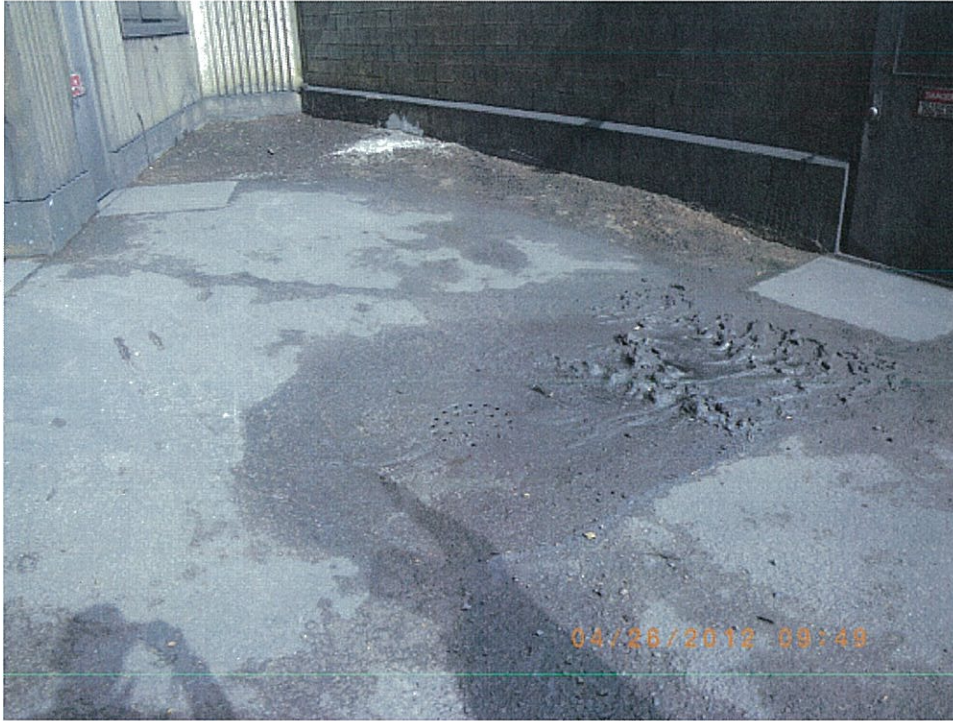
entire east side of the generating station including the ash handling and transport areas, old ash storage area, and the paved area between the generating station and the maintenance building (Appendix I). This catch basin discharges into effluent pond 3. The catch basin was surrounded by solids, including what I observed as ash (Photo IMGP0927). The area around the catch basin, which included the old ash storage area (Photo IMGP0928), contained particulate debris.

Photo IMGP0927: Catch basin on the northeast side of the generating station that discharges to effluent pond 3.

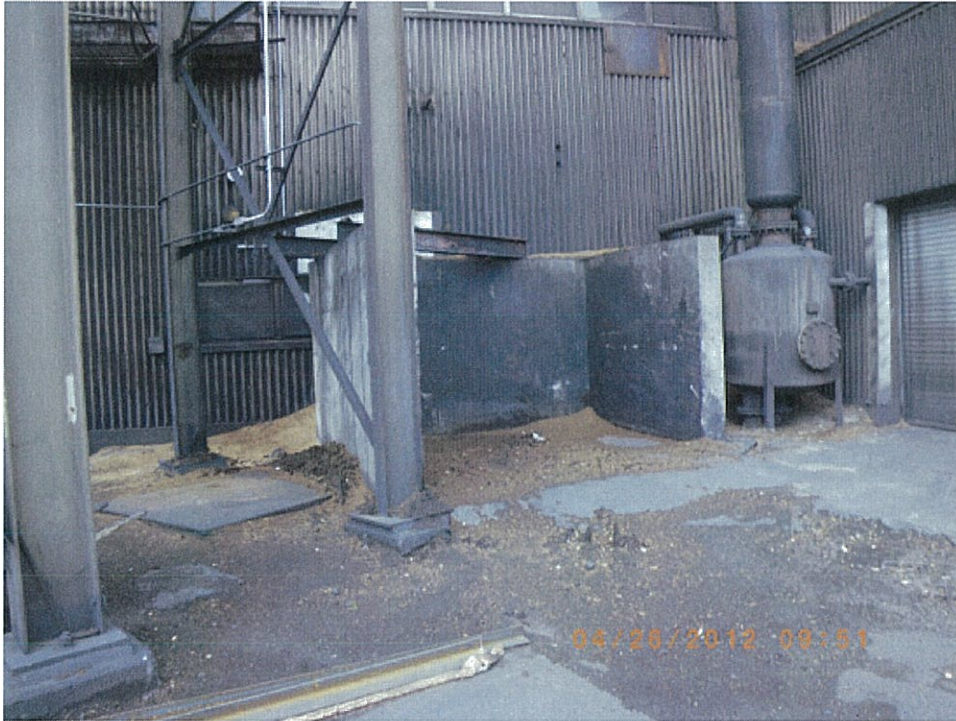
Photo IMGP0928: Old ash storage area on the northeast side of the generating station. The old ash storage area is adjacent to the storm water catch basin that discharges into effluent pond 3.  
Direction: Facing west.

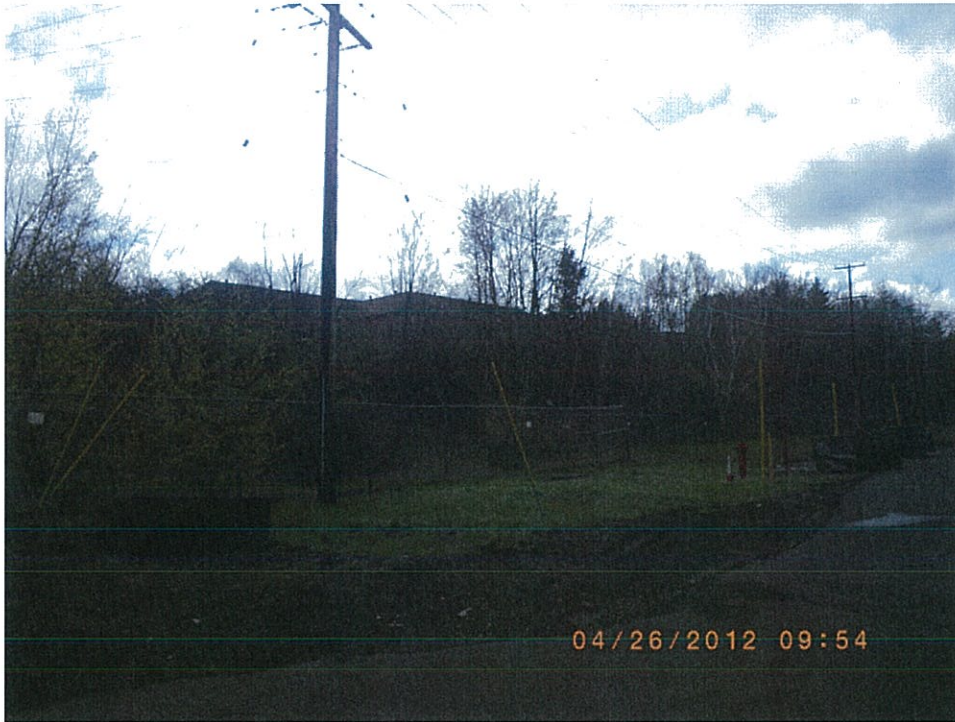
I observed that there was a large berm along the northeast side of the facility. Darryl Koski stated that the berm was an old railroad line (Photo IMGP0930). The berm was greater than 20 feet in height and would prevent any runoff from leaving JHWS to the northeast.

Photo IMGP0930: Berm along the northeast side of JHWS that is a former railroad line.  
Direction: Facing east.

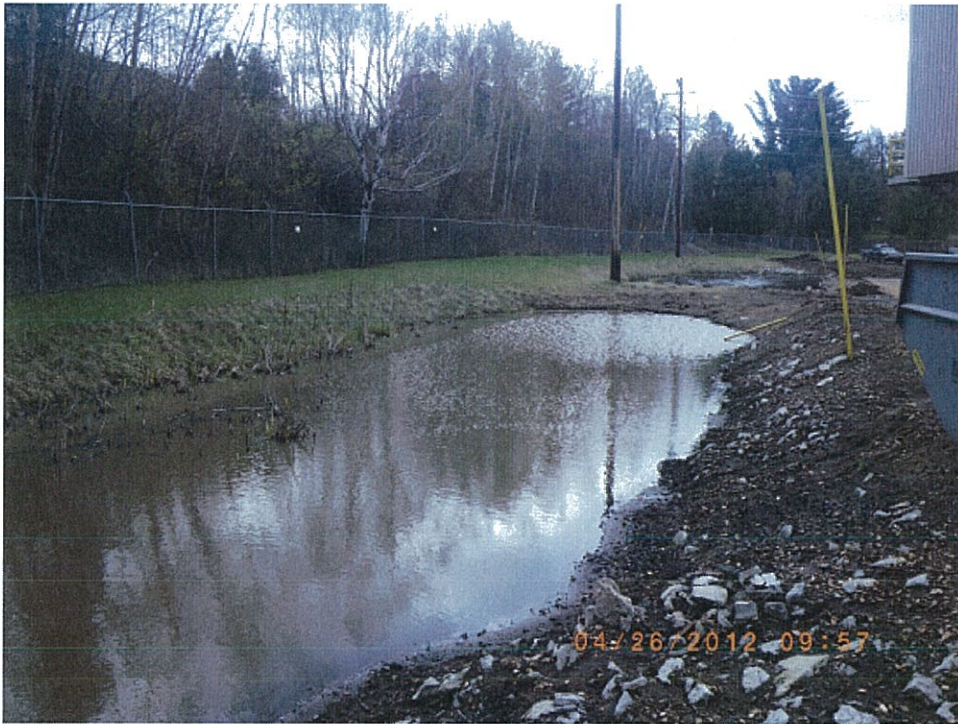
Photo IMGP0932: Storm water pond 2 which includes two retention ponds along the northeast side of JHWS.

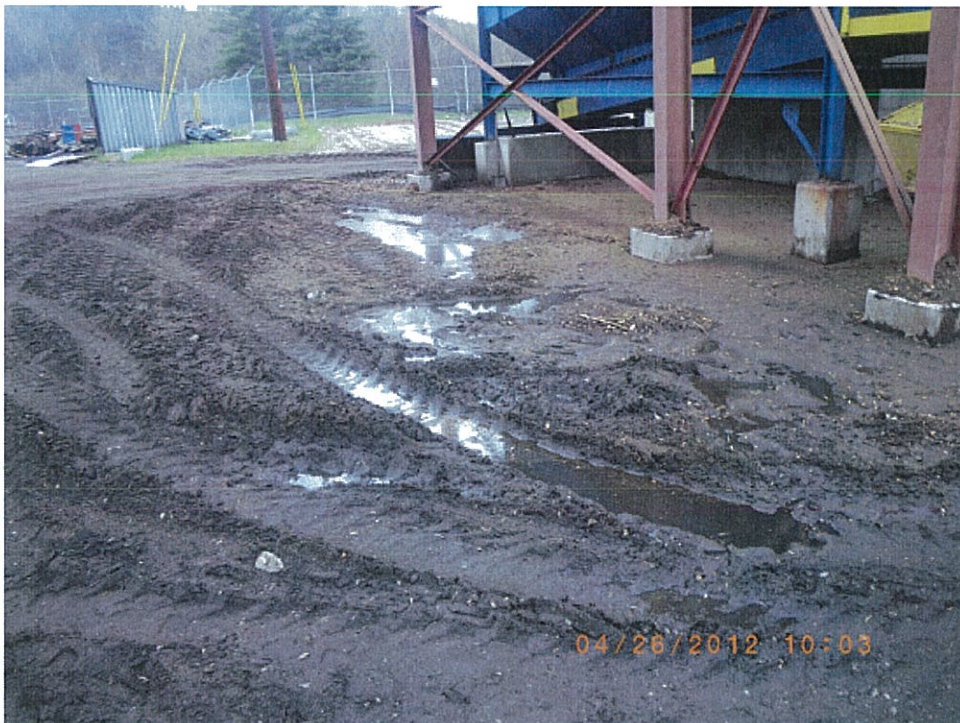
Photo IMGP0936: Flow path for potential overflows from storm water pond 2.

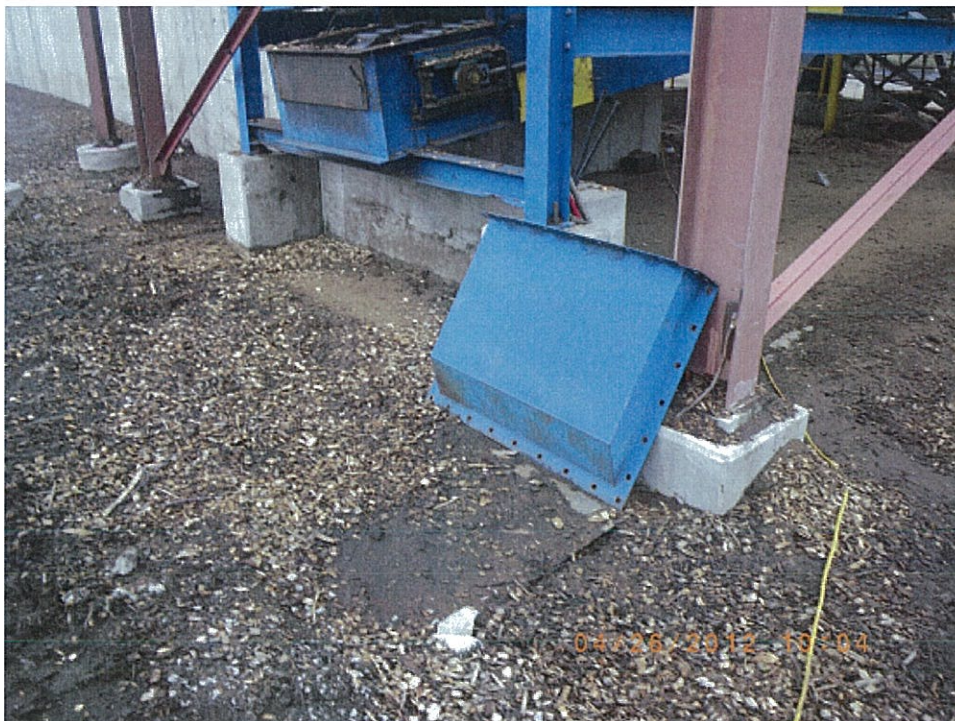
Photo IMGP0937: Culvert inlet (Note the inlet in the front center of the photo covered by a metal sheet and located at the base of the blue metal cover on the ground.) adjacent to the receiving hopper leading to storm water pond 1.

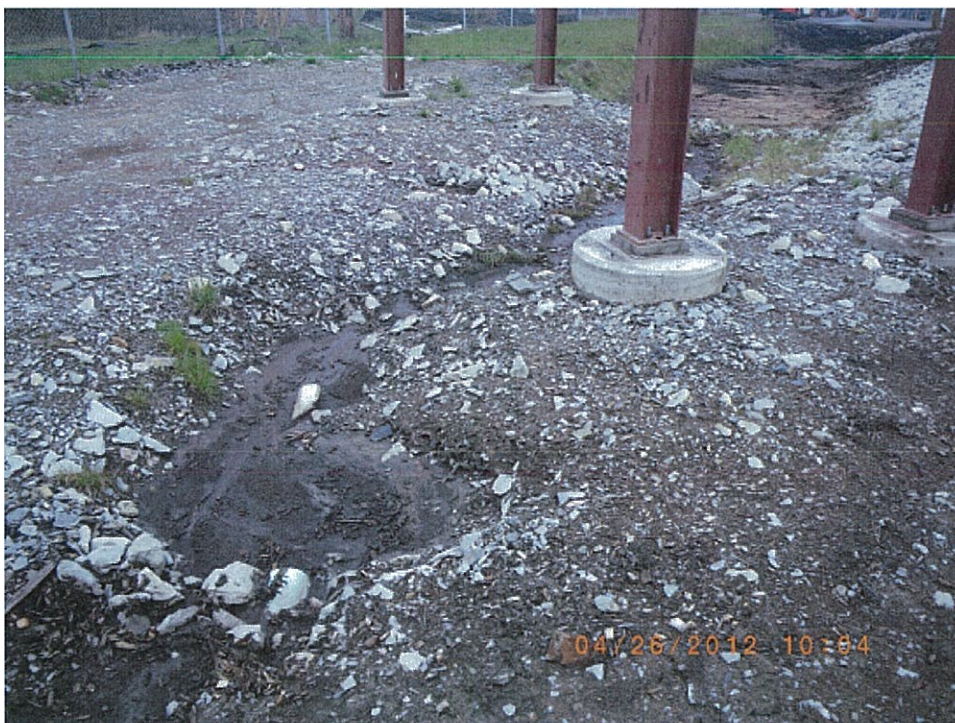
Photo IMGP0938: Culvert outlet and ditch leading to storm water pond 1 in the background.

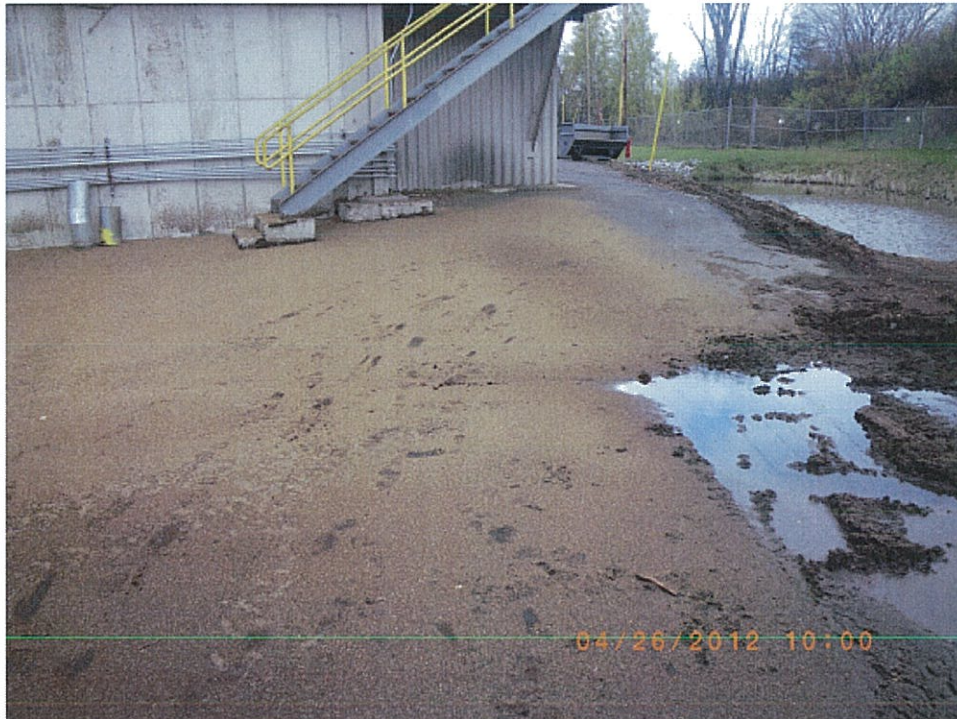
Storm water pond 2 receives storm water flow from off of the railroad berm, from the northeast to south side of the biomass fuel storage building and from the area around the receiving hopper and first belt conveyor (Appendix I). I observed that the area under the receiving hopper and first belt conveyor was covered in wood fines (Photo IMGP0935). I observed that wood fines were falling from the first conveyor when I stood on the southwest side of the biomass fuel storage building. The wood fines had accumulated in large piles along the edge of the south storm water pond 2 (Photo IMGP0934).

Photo IMGP0935: Wood fines on the ground underneath the first belt conveyor, note the accumulated piles of wood fines on the right.  
Direction: Facing northwest.

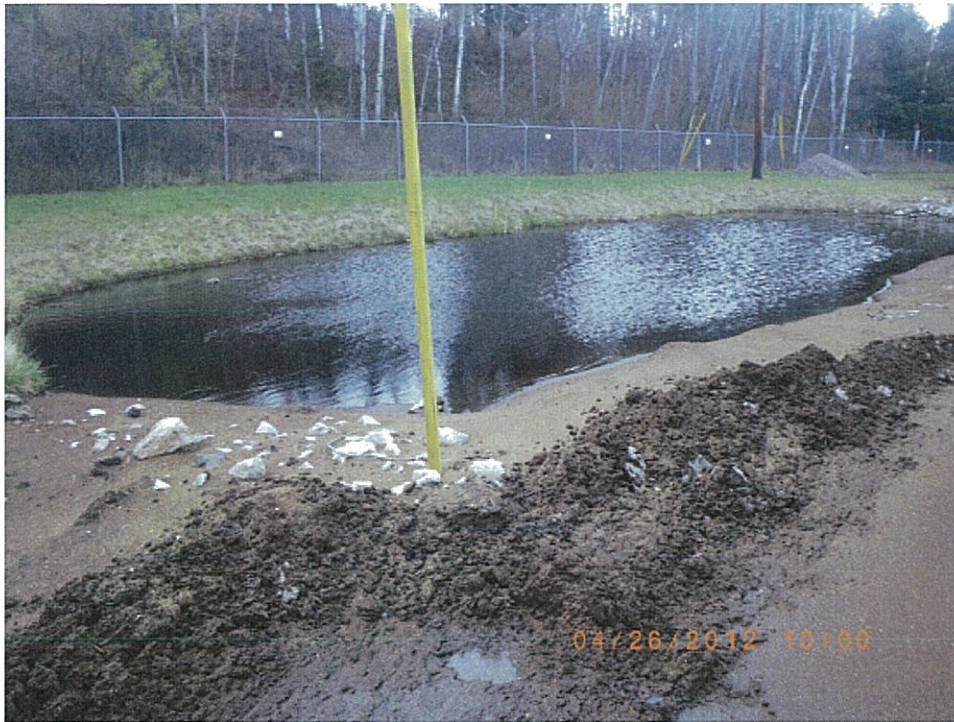
Photo IMGP0934: Accumulated wood fines on the edge of the south storm water pond 2.  
Direction: Facing east.

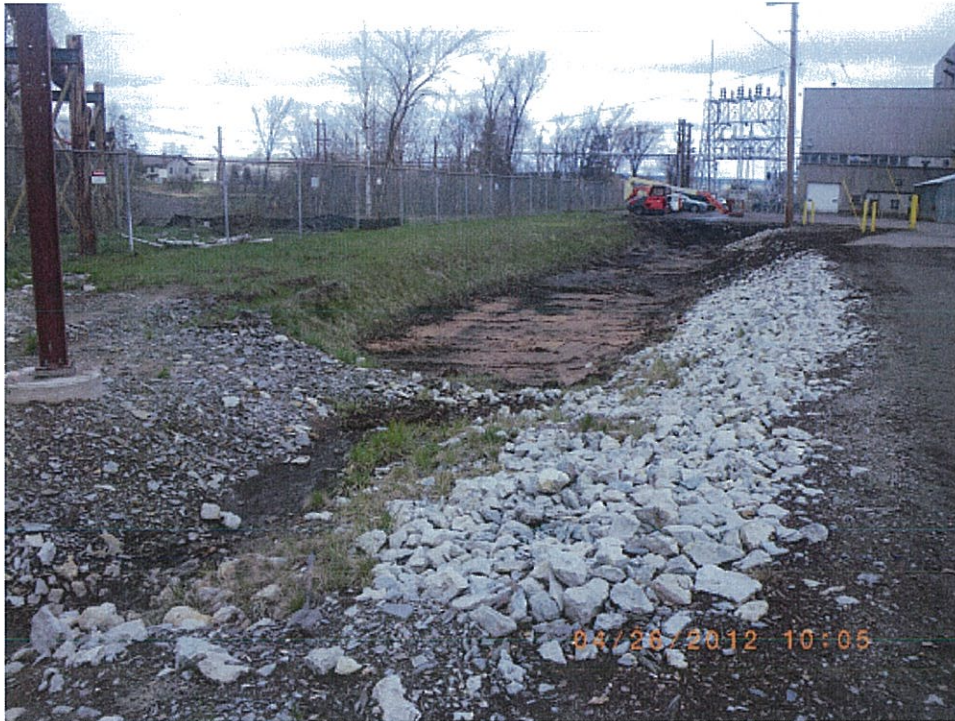
I observed that storm water pond 1 had recently been dredged and contained no water during the inspection (Photo IMGP0939 and IMGP 094040). Darryl Koski stated that storm water pond 1 almost never contains water because of rapid infiltration. He also stated that the pond was recently dredged to remove all of the TDF that was in storm water pond 1. Storm water pond 1 receives flow from the asphalted area around the southwest side of the biomass fuel storage building and some areas under the second belt conveyor (Photo IMGP0933 and Appendix I).

Photo IMGP0939: Storm water pond 1 containing no water and recently dredged.  
Direction: Facing northwest.

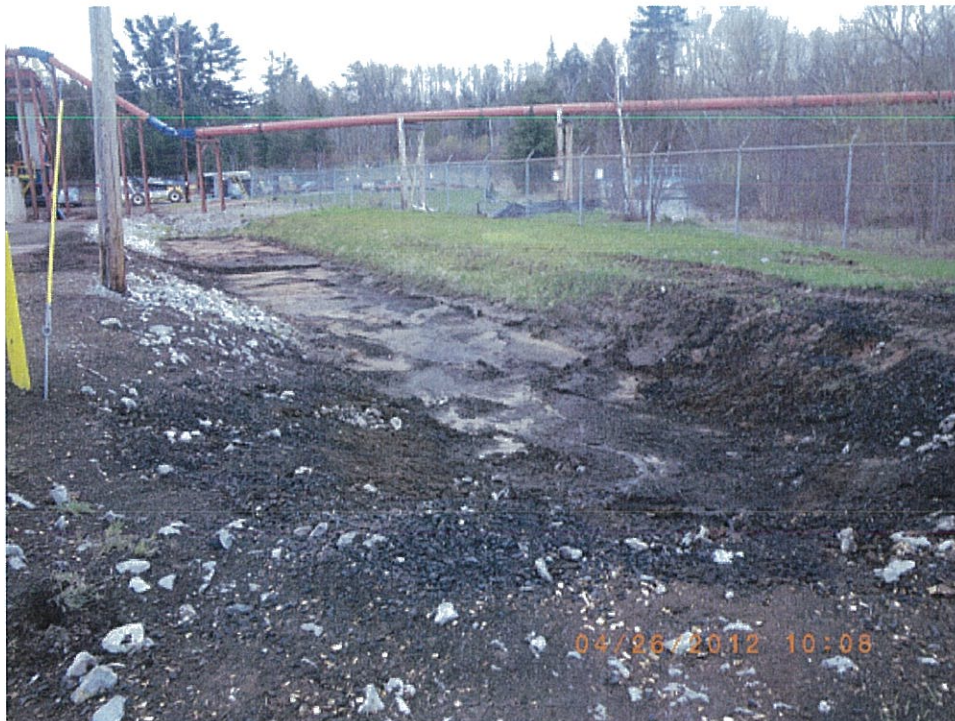
Photo IMGP0940: Storm water pond 1 with the pneumatic conveyor and receiving hopper in the background.  
Direction: Facing southeast.

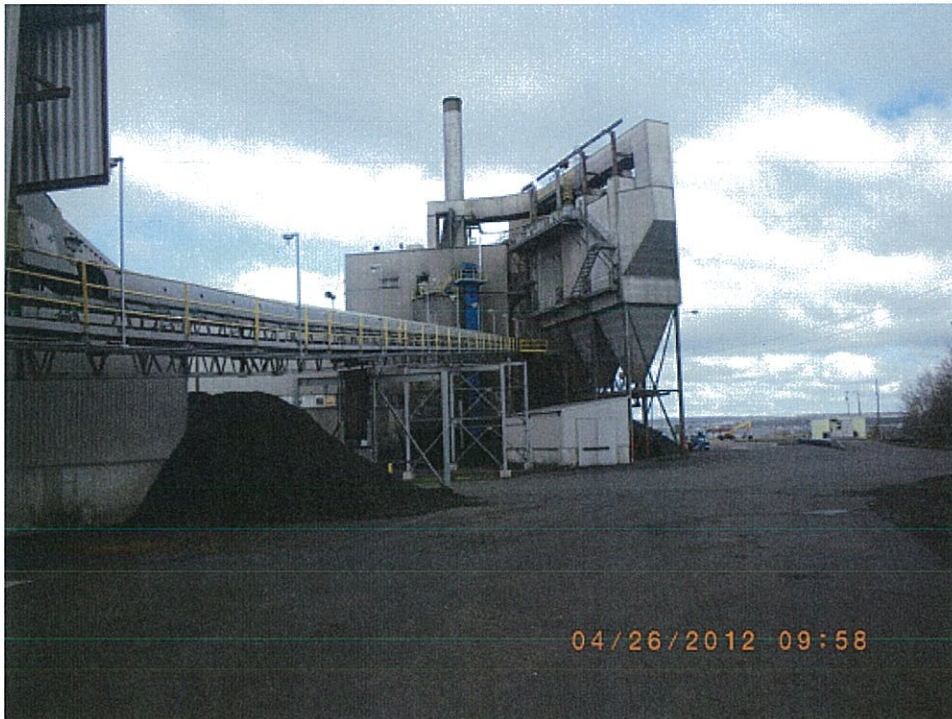
Photo IMGP0933: Second belt conveyor leading to the boiler with the TDF pile underneath.  
Direction: Facing northwest.

TDF was proportionally added to the wood chips at the biomass fuel storage building, where some of the TDF was being stored. I observed that most of the TDF on site was stored in a pile underneath the second belt conveyor on the northwest side of the biomass fuel storage building (Photo IMGP0931 and IMGP0933). Runoff from TDF would flow either to storm water pond 2 or into storm water pond 1.

conveyor systems and ash storage building. TDF should be stored where it does not come into direct contact with storm water.

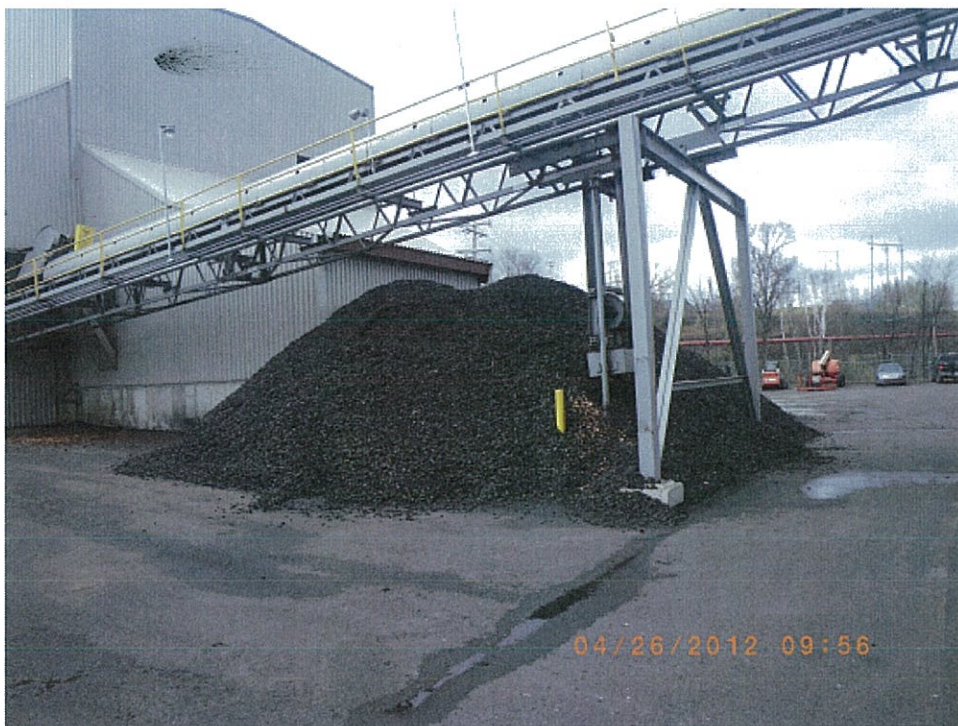
Photo IMGP0931: TDF is stored underneath the second belt conveyor with storm water from the pile flowing both northeast from the front of the pile and southwest from the far side of the pile. Direction: Facing southwest.

4. Section 4.0(G) of the SWPPP states that all solid fuel would not contact storm water unless a spill occurred and was not cleaned up. This is not consistent with the TDF that was stored outside at the time of the inspection.

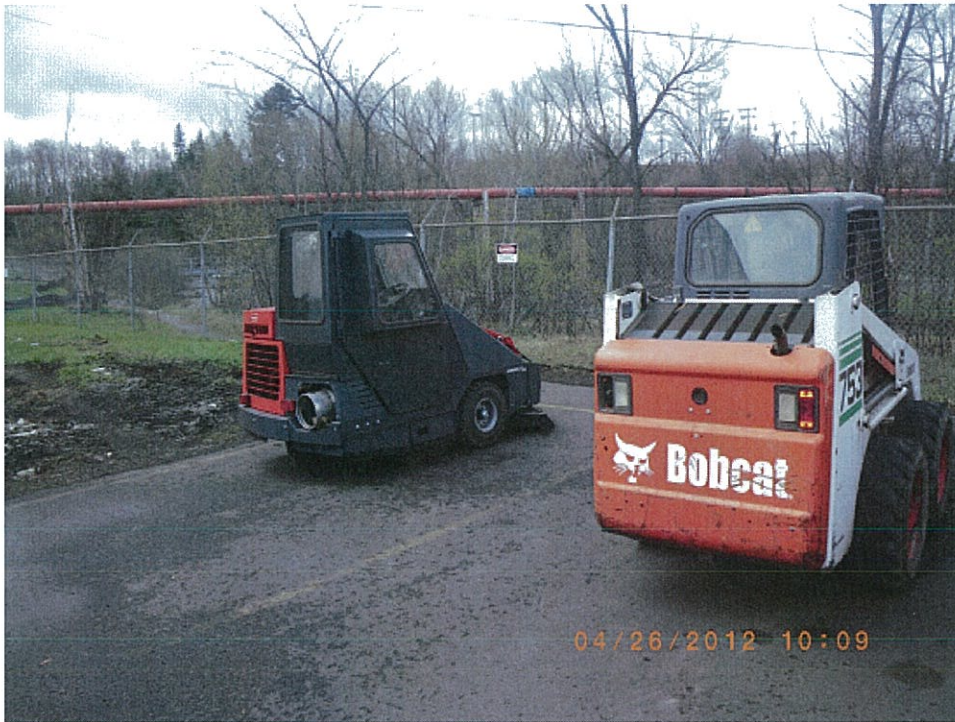
I observed that the LWEC had a small sweeper on site (Photo IMGP0941). Darryl Koski stated that the sweeper was recently purchased and that it was used for good housekeeping around JHWS including at the ash loading area.

Photo IMGP0941: Sweeper used to clean up areas of JHWS.  
Direction: Facing southwest.

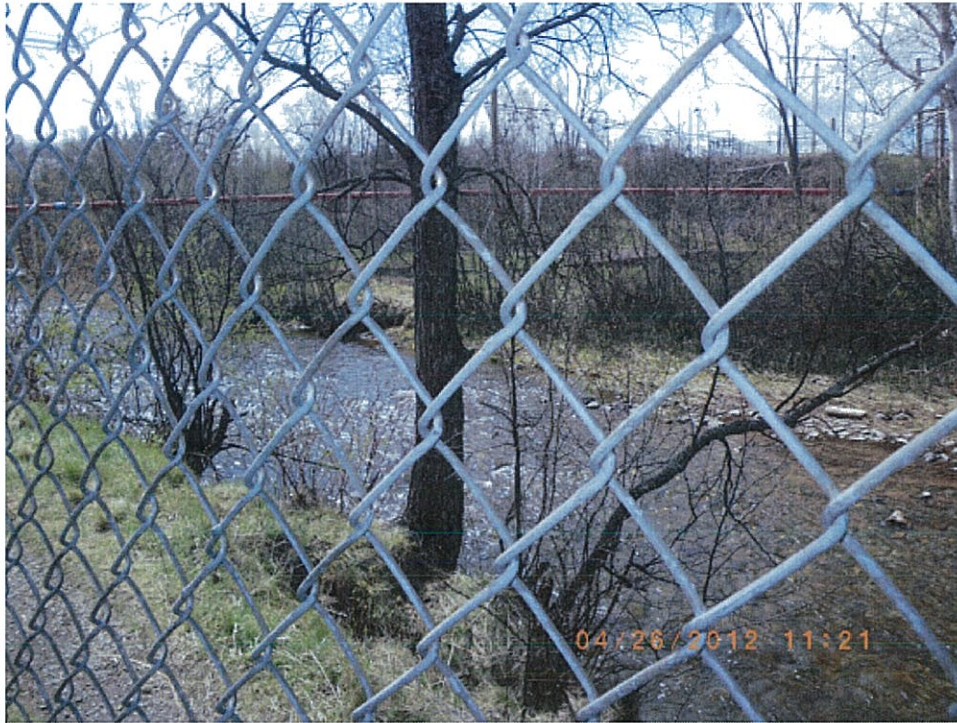
The south side of JHWS is a grassed and wooded area that sloped towards Falls River. The southwest side of the facility that borders Falls River is grassed and contains brush (Photo IMGP0970). I observed no noticeable runoff pathways from JHWS to Falls River.

Photo IMG0970: Falls River along the southwest side of JHWS.  
Direction: Facing south.
